VOL. 1

TROUBLE SHOOTING

SECTION 4

Trouble Shooting

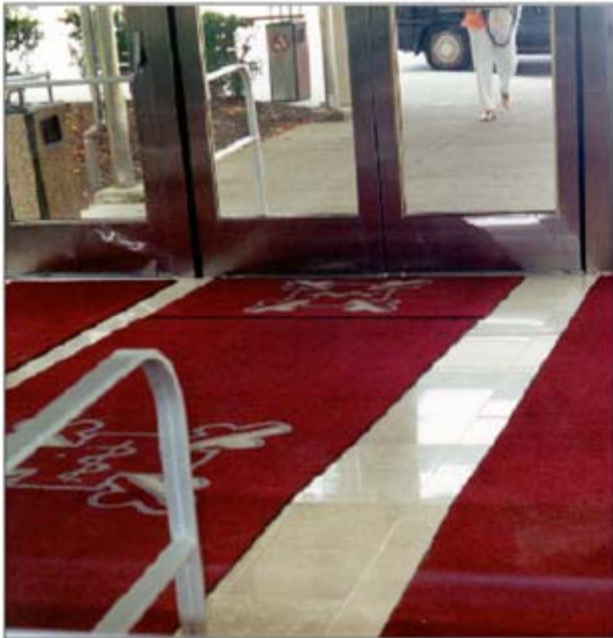
Floor mats in Front Lobby.

Floor material is slick when wet, causing a slipping/falling hazard for patients, visitors and staff. In most cases, the flooring material is either vinyl composition tile, seamless vinyl or terrazzo tile (surfaces which have no grit or abrasion).

1. **Provide walk-off mats at entrances, and slip-resistant mats where the problem is noticeable and the pedestrian traffic is heavy.**

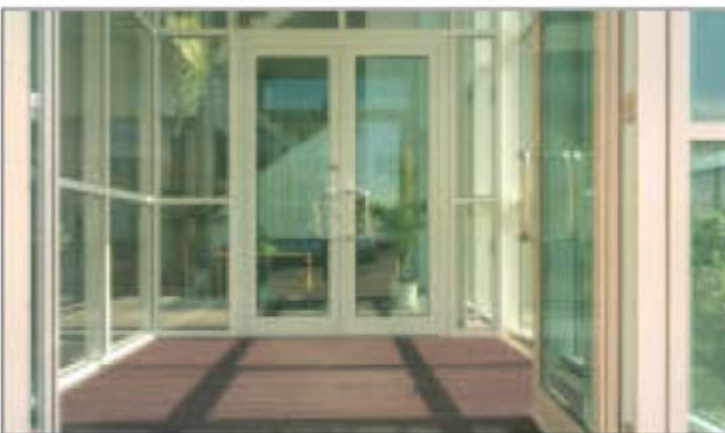
Example of recessed walk-off mat.

Note: A recessed walk-off mat at entrance can be installed in lieu of the rubber mats thrown on floor. Costs are increased due to chipping out the floor in a vestibule or just inside the lobby doors, but the result is a coordinated flooring system that attractively offers slip resistance and dirt/water removal at the entry points. Walk-off materials range from vinyl to carpet.

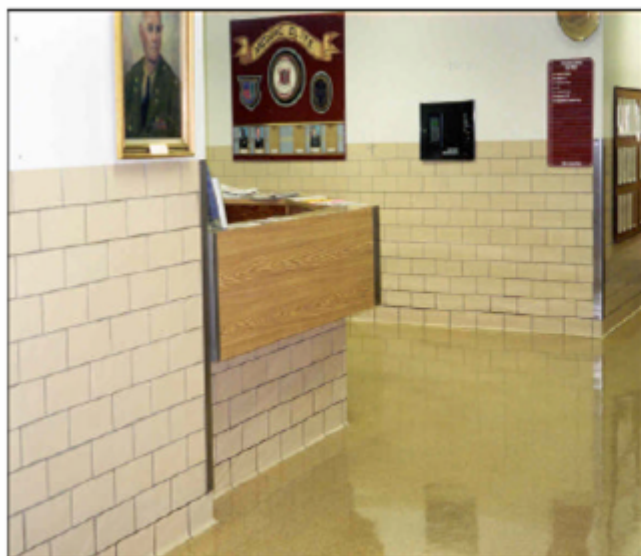
Structural Glazed Block in Corridors.

Structural Glazed block walls are installed down major corridors, giving the facility an outdated and institutional appearance. Blocks meet the plaster wall surface approximately 60" above the finished floor, which contributes to the awkward scale of the space, and limits the use of artwork and signage. Many of these walls have a base tile that is lipped or coved, presenting an institutional look.

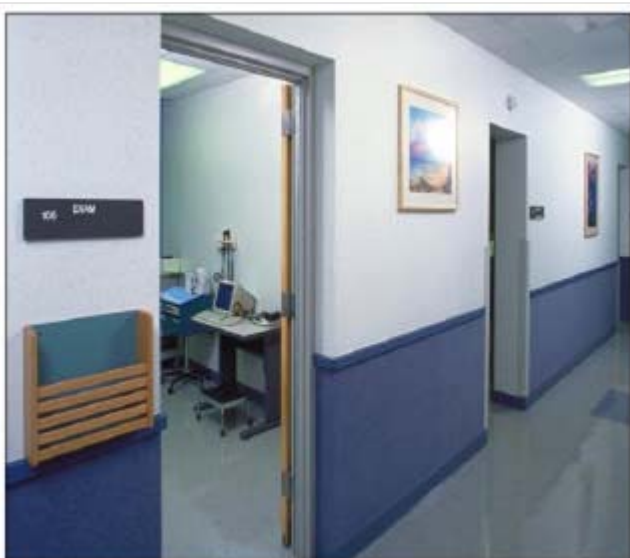
Example of wallcovering and paint in Corridors.

2. **Skim out block wall at grout joints and block/plaster juncture and install vinyl wallcovering over block and plaster.**

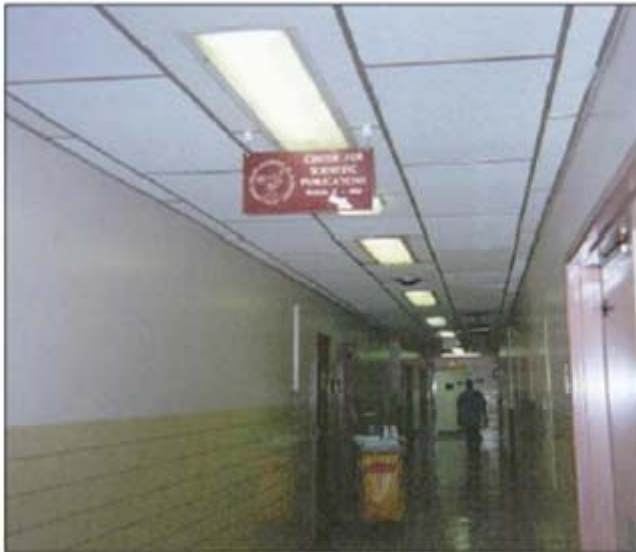
Inconsistent acoustical ceiling tile styles, old grid.

Ceiling tiles installed throughout the facility are soiled and stained and T-grid appears discolored. Ceiling surface is dull and detracts from the interior environment. Ceiling tile styles and details may not be consistent throughout the facility. Tiles may sag, gap or may be damaged.

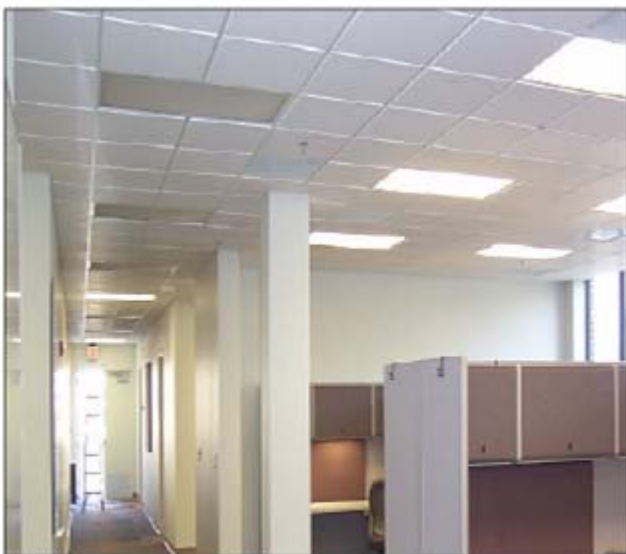
New ceiling tiles in 2' x 2' grid.

3. Replace entire ceiling system with new grid and 2'x 2' ceiling tiles.

Advantages: Creates a clean, consistent ceiling system; may improve acoustics depending upon the type of ceiling tile selected; reduces sag potential due to smaller tile size; provides improved light reflectance.

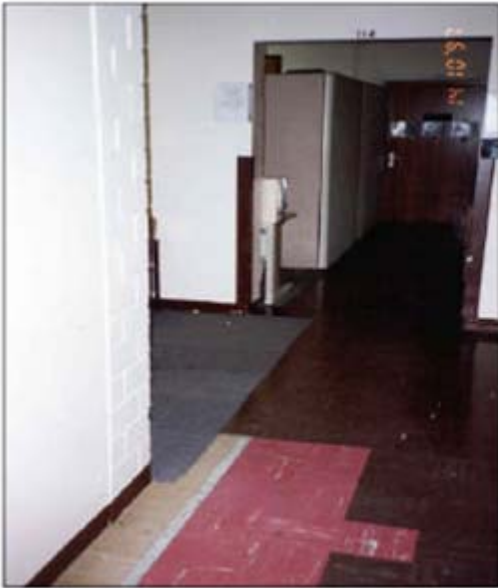
Lack of Wayfinding cues in corridor.

Facility is looking for ways to improve wayfinding cues and create more interest in their public spaces. Public corridors are typically outfitted with vinyl composition tiles or other type of resilient flooring, painted walls or vinyl wallcovering, and acoustical ceiling tile system. Interior signage is provided, but may be minimal or overkill, lacking balance and proper placement.

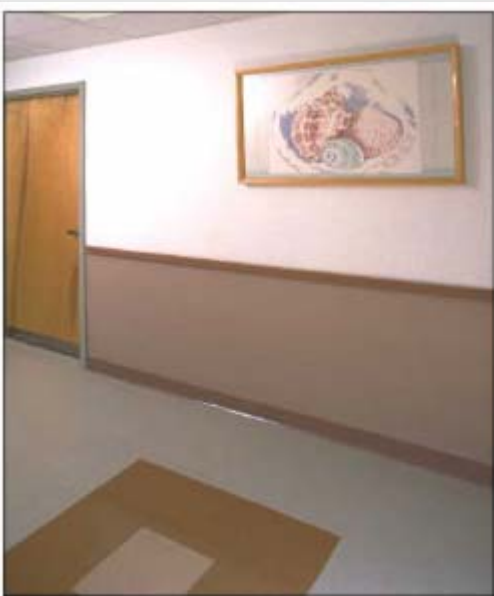
Example of Wayfinding cues in corridor.

1. **Create floor patterns at major corridor intersections and elevator lobbies with vinyl composition tile accents inlaid into existing VCT.**

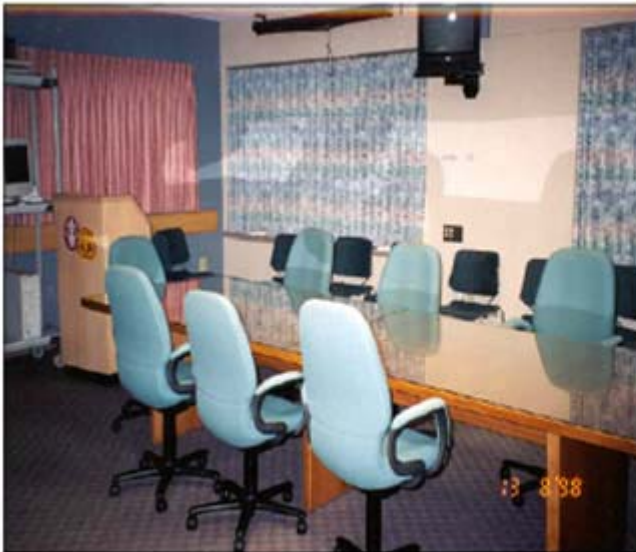
Inconsistent an inappropriate drapery fabrics and hardware in conference room.

Facility is seeking a comprehensive solution to window treatments throughout the facility. Windows currently incorporate several different products and materials as treatment, creating a “non-standard” solution. When viewed from the exterior, windows in the building display several different types of treatment solutions, which add to the disjointed and “non-standard” appearance.

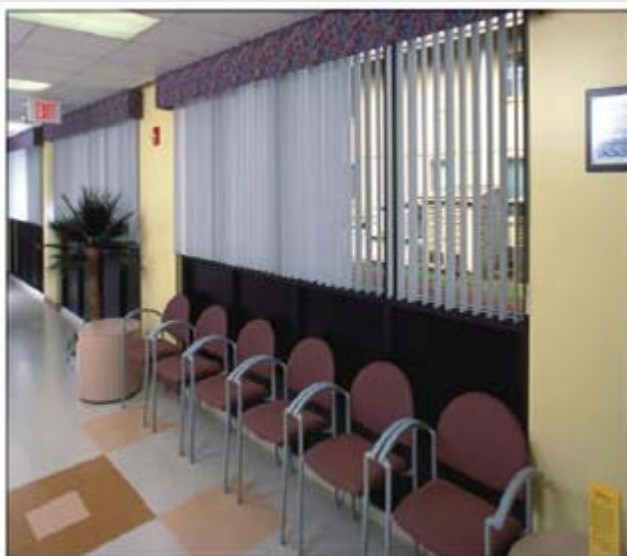
Example of vertical blinds with upholstered cornice boards on window.

2. **Provide vertical blinds to perimeter windows.**

Note: The above two options may be "dressed up" in public areas with an upholstered cornice board or fabric valance that provides color and pattern.
